# STREAM SURVEYS OF THE SHEEPSCOT AND DUCKTRAP RIVER SYSTEMS IN MAINE

SPECIAL SCIENTIFIC REPORT-FISHERIES No. 195

UNITED STATES DEPARTMENT OF THE INTERIOR  
FISH AND WILDLIFE SERVICE

Floyd G. Bryant  
Fishery Research Biologist

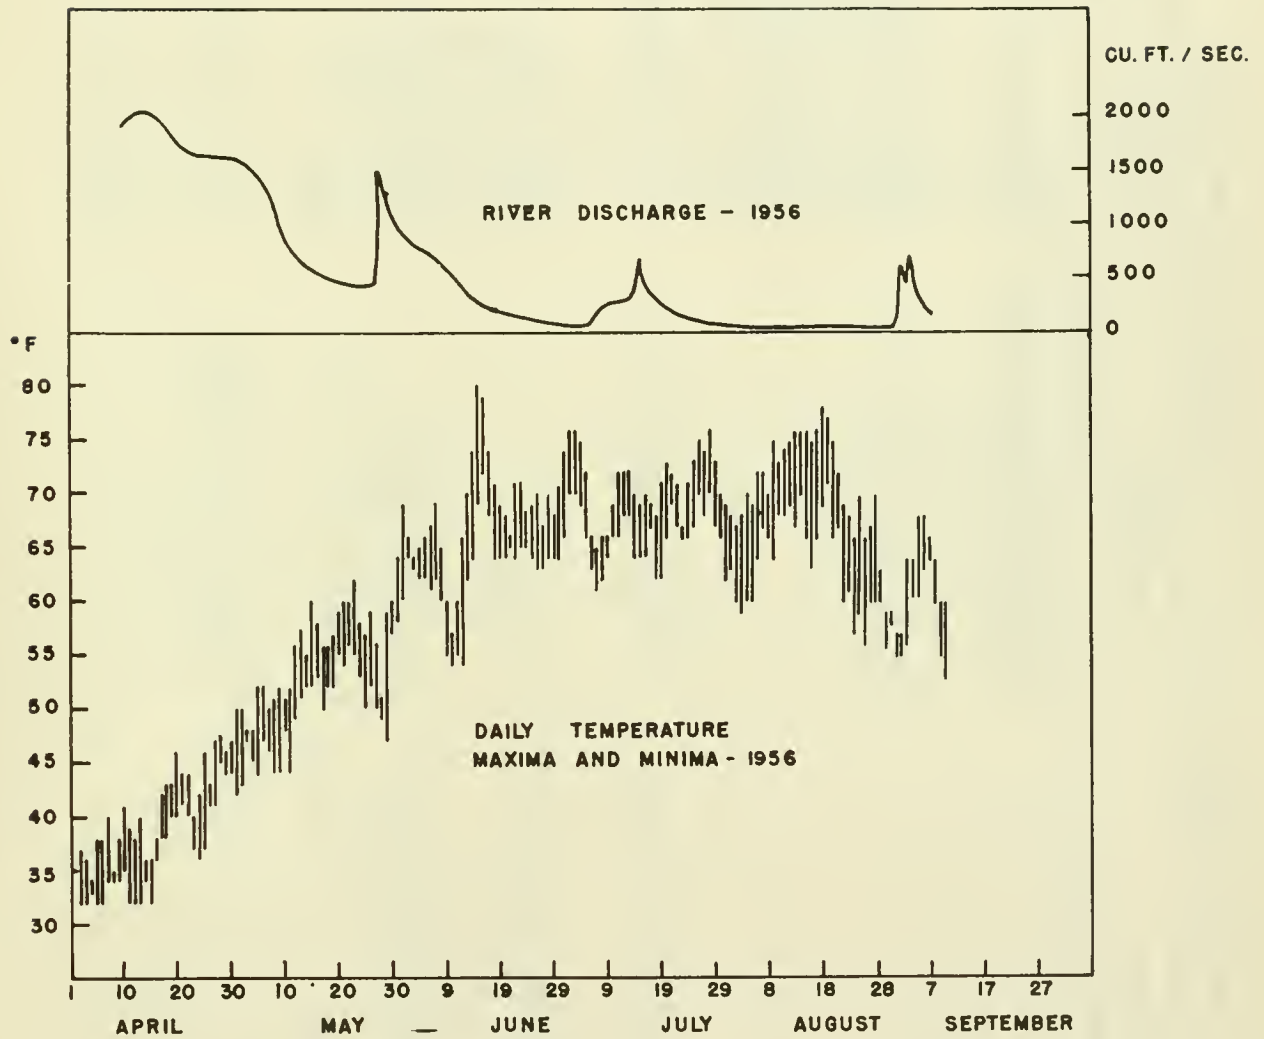
Figure 2.--Daily water temperatures and discharge volume of the Sheepscot River for the spring and summer of 1956.

usually occur in September and October after prolonged dry periods. Figure 2 shows the seasonal trend for 1956.

Observed water temperatures of the main river ranged from 62° F. to 75° F. during the period of survey. These observations have been supplemented by a more extensive series of thermal data recorded on a thermograph. The daily water temperatures for part of a single year are shown in figure 2. Other thermograph records have been made in various sections of the river at other times. Temperatures seldom exceed 80° F. except in the quiet sections of the river, particularly the tidal portion. The highest recorded temperature was 88° F., an extreme of only a few hours' duration.

Temperatures recorded at Whitefield, Maine.  
 Discharge recorded at Alna, Maine.
