A FISHWAY THAT SHAD ASCEND

SPECIAL SCIENTIFIC REPORT: FISHERIES No. 65

UNITED STATES DEPARTMENT OF THE INTERIOR
FISH AND WILDLIFE SERVICE

By Gerald B. Collins
Fishery Biologist

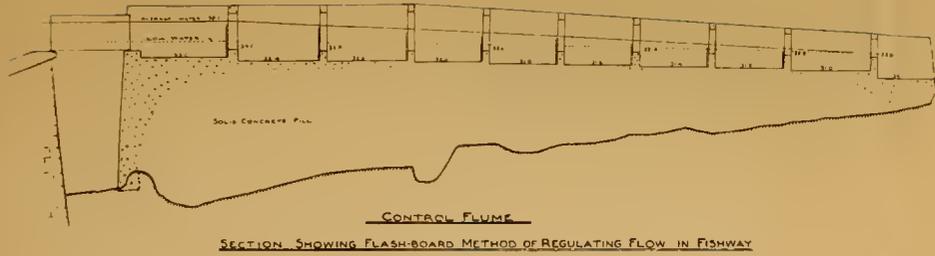
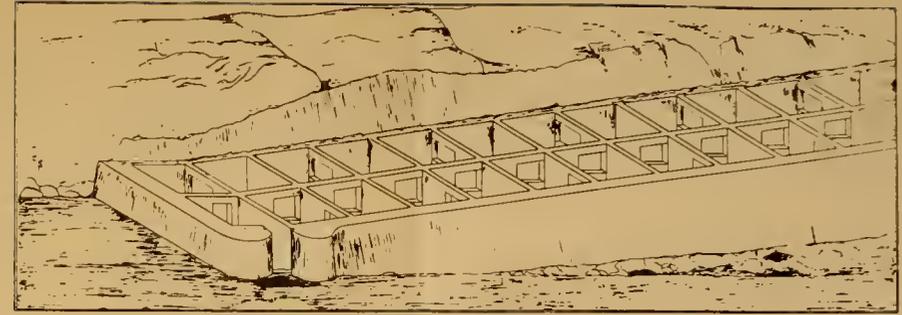
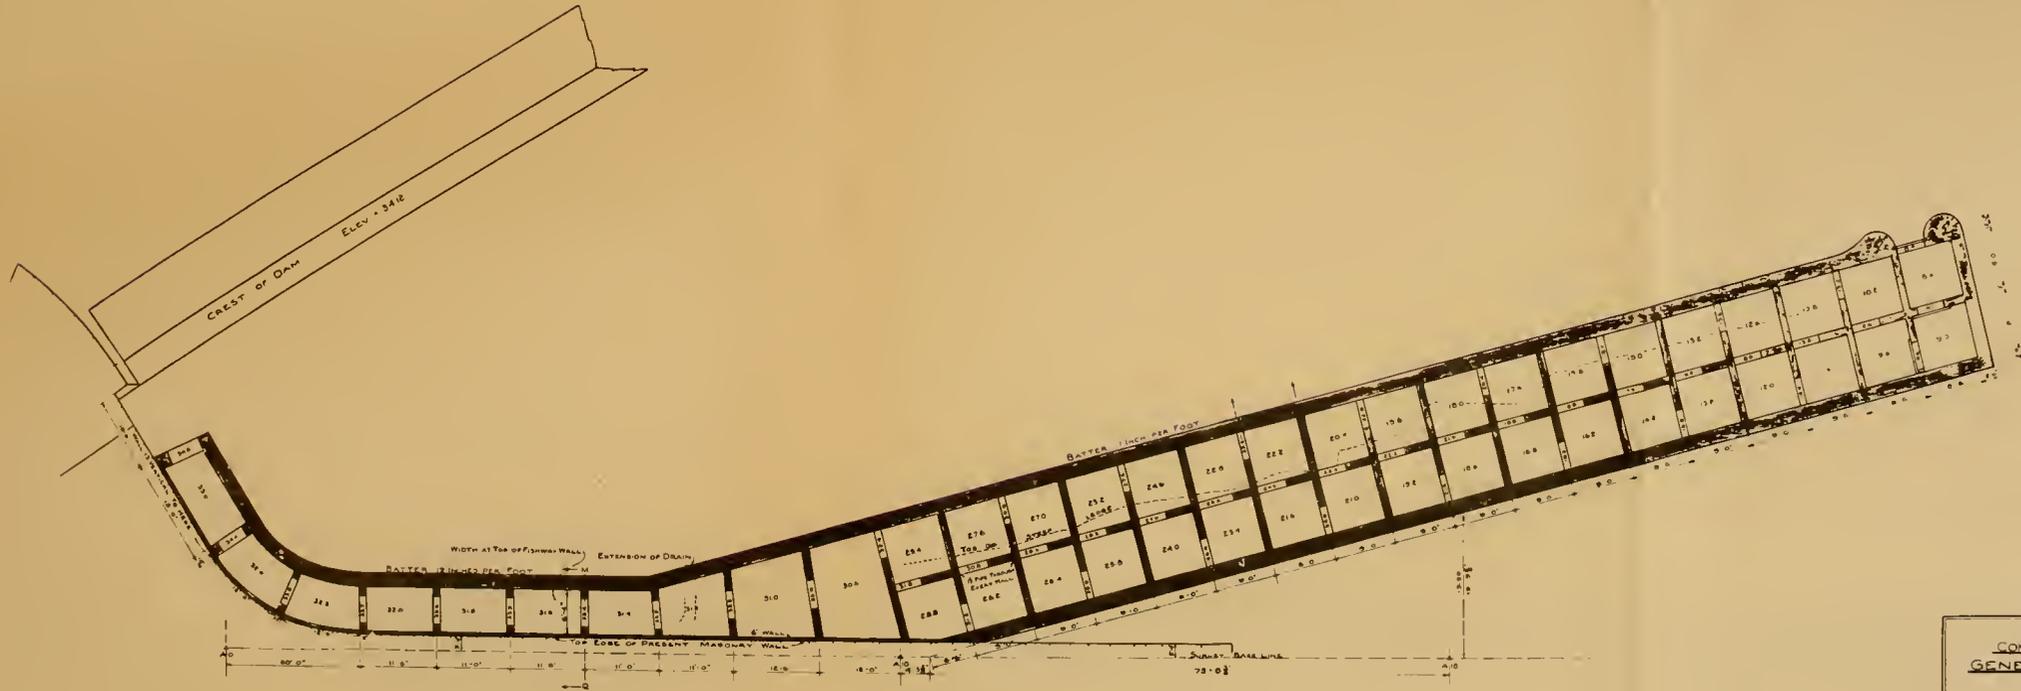
Figure 1. -- Plan of Lawrence Fishway
 Note that original weirs were 4 feet in width.
 (Modified in 1937).

COMMONWEALTH OF MASSACHUSETTS
 COMMISSION ON FISHERIES AND GAME
 GENERAL PLAN OF PROPOSED FISHWAY
 AT DAM OF THE
 ESSEX COMPANY
 LAWRENCE, MASS.
 SCALE 1/4"=1' HORIZONTAL
 BIRDBRING HAYWARD, CIVIL ENGINEER, TAVENNER, MASS. NOVEMBER 30, 1918

In 1936, the fishway was severely damaged by flood waters. The following year major repairs were undertaken and at the same time several modifications were made. The most important of these changes was an alteration of the weirs. In crossing the original weirs which were 4 ft. wide (Figures 1 and 2), the deep-bodied shad sometimes had difficulty because of the relative shallowness of the water (from 2 in. to 6 in. in depth). Fish examined in the upper part of the fishway were frequently found to be badly scraped. To remedy this condition, in 1937 notched weirs were constructed on top of the original weirs. Each of the notches (Figure 11) is 2 ft. wide at the top, 1 ft. wide at the bottom and 1 ft. deep. The floor of each notch is sloped at an angle of 30°. The top of the notched weir is 1.5 ft. above the original weir. This modification not only resulted in a deeper flow across the weir but it raised the average depth of the water in the pools when the fishway was in operation from less than 3 ft. to more than 4 ft.

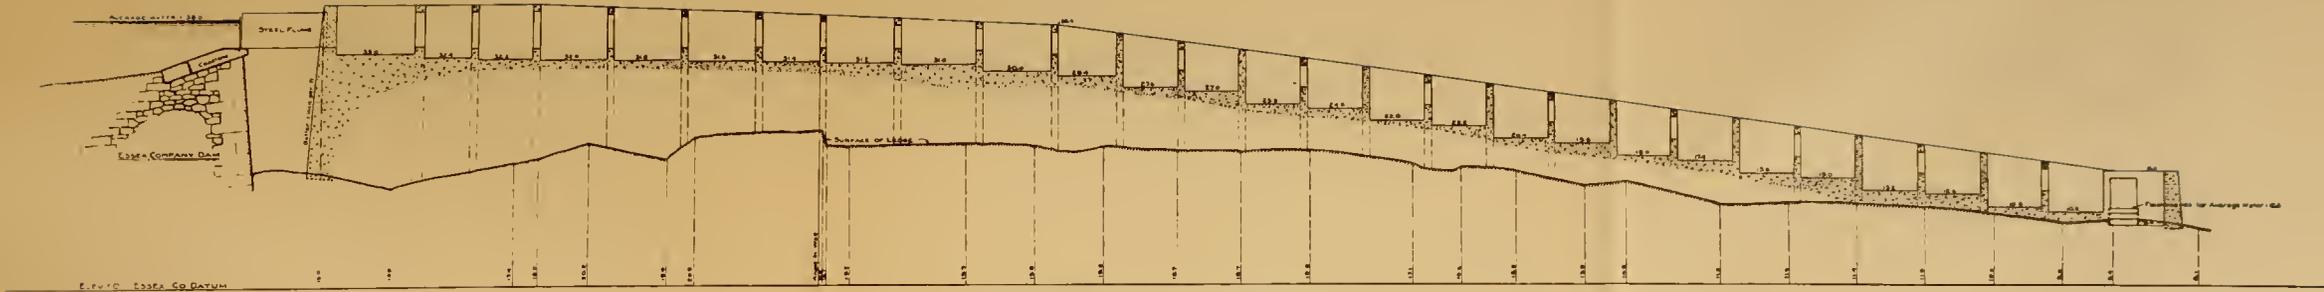
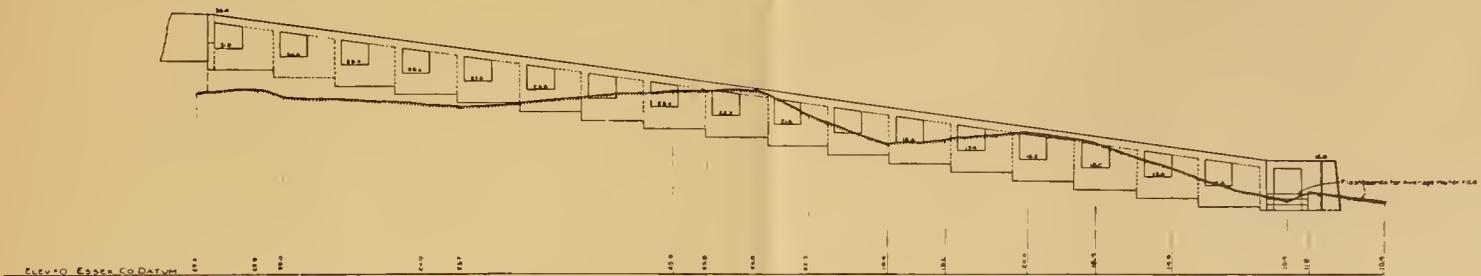
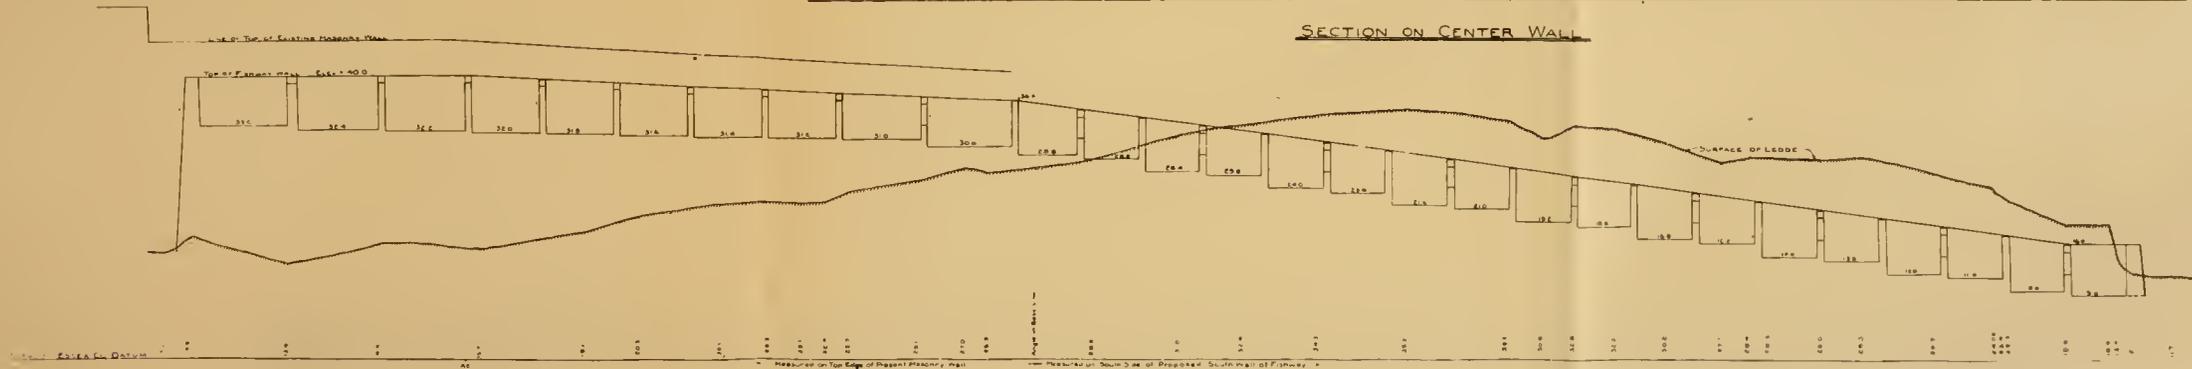
PROFILE OF NORTH WALL OF FISHWAY

SECTION ON CENTER WALL

PROFILE OF SOUTH WALL OF FISHWAY

Figure 2. -- Profile of Lawrence Fishway
 Note lower flashboards. These proved difficult to maintain. (Modified in 1937).

Because the shad did not enter the fishway under high tailwater conditions (tailwater elevations of 15 ft. above mean sea level or greater) in 1937 an opening was cut in the side of one of the lower pools (Figures 4 and 9) to allow the fish to enter the fishway without passing through the turbulent area (Figure 7) near the entrance.^{2/} Another change that was made in 1937 was the replacement of the adjustable plank weirs in the lower 3 pools ("flashboards" of Figure 2) with notched concrete weirs.

The characteristics of flow in the fishway entrance and in the lowest two pools ^{5/} were studied under a variety of tailwater conditions (Figures 13, 14, 15). Flow patterns made with both the original "flashboard" arrangement (Figure 2) and with the notched weirs installed in 1937 showed only minor differences because the weirs are flooded throughout most of the range of tailwater elevations at which shad enter the fishway. The flow in the lowest pool and through the entrance was remarkably uniform and lacking in turbulence. Velocities through the entrance ranged from a maximum of 2.6 ft/sec. at a tailwater elevation 11 ft. (above mean sea level) to less than 0.5 ft/sec. at a tailwater elevation of 14.5 ft. (above mean sea level). The large curved reinforcements on each side of the entrance created an area with lower velocities just outside the entrance (Figures 13, 14, 15).

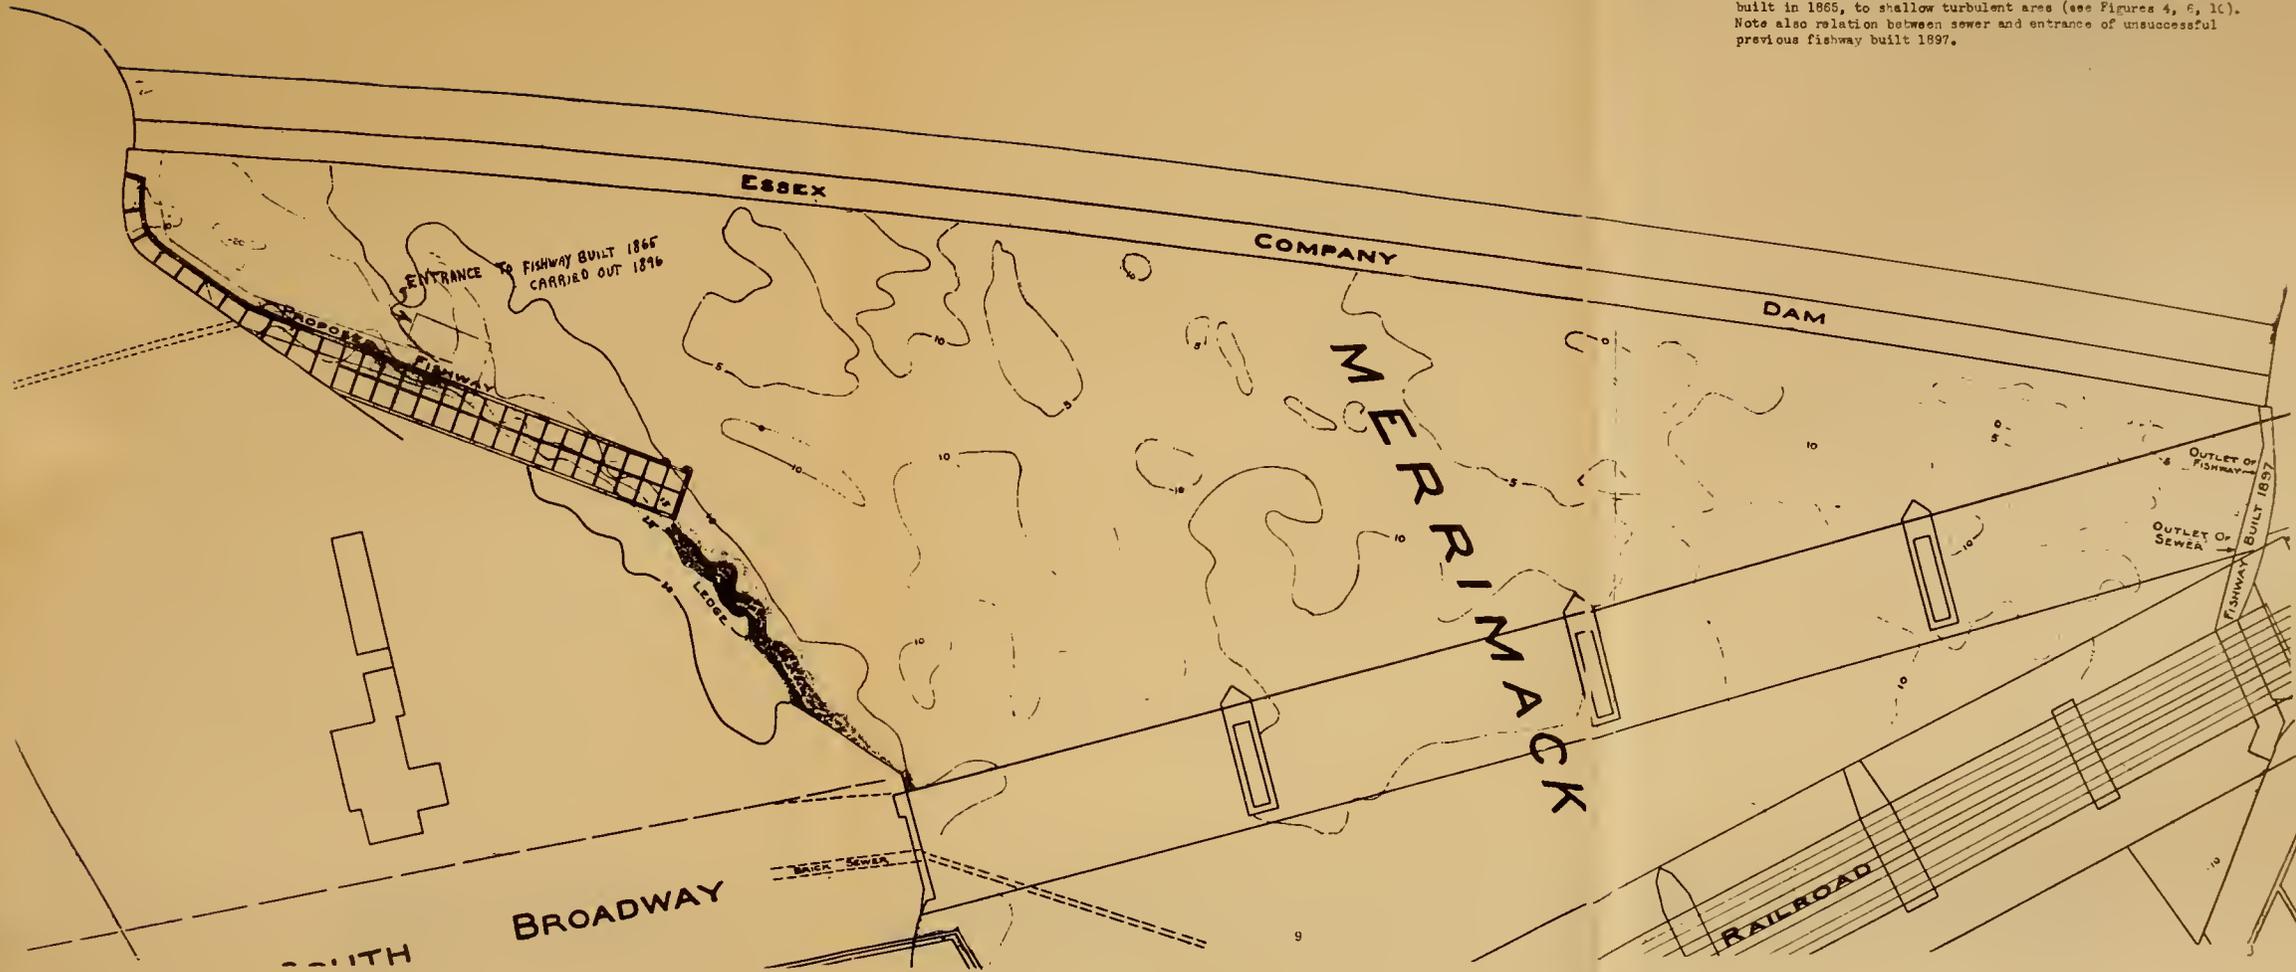
Figure 3. -- Location of Lawrence Fishway
Note relation of fishway entrance to river channel and to shore.
Note relation of entrance of unsuccessful previous fishway,
built in 1865, to shallow turbulent areas (see Figures 4, 6, 1C).
Note also relation between sewer and entrance of unsuccessful
previous fishway built 1897.

The entrance to the fishway is 4 ft. in width and is located at the edge of one of the main channels (Figure 3). In a normal year the new wood used for flashboards on the crest of the dam is placed on the north side of the dam. During the winter the weaker boards on the south side of the dam frequently become damaged by ice and are washed out so that in the spring the flow is concentrated in the channel next to the fishway entrance. Large curved reinforcements on each side of the entrance (Figure 1), probably designed to strengthen the fishway structure at the opening, may actually be responsible for a large measure of the fishway's success with shad.

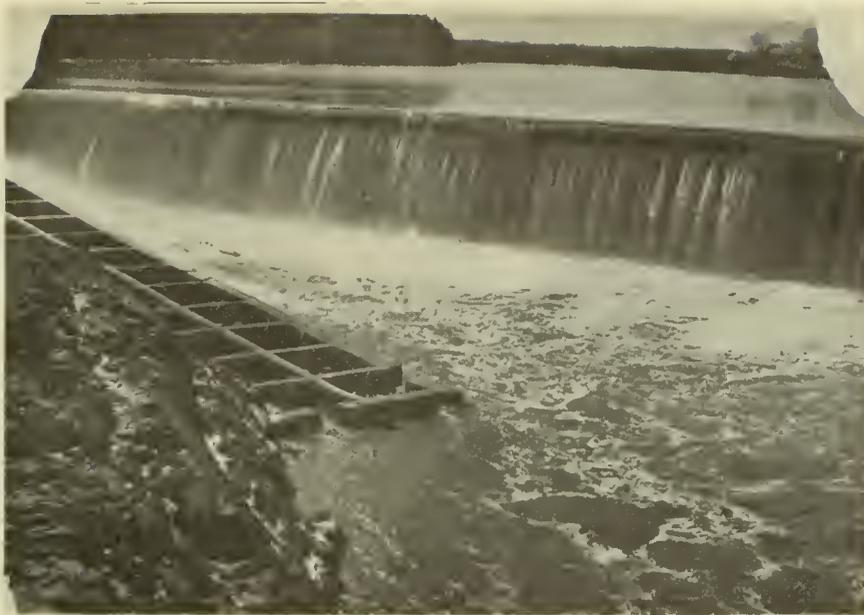
Figure 4.-- General View of Lawrence Fishway

Tailwater Elevation 14.5 ft. (above mean sea level). This water level probably represents the maximum tailwater level under which shad enter the ladder. Water velocity through fishway entrance about 0.3 ft/sec. Note opening (3 ft. x 3 ft.) cut in side by second pool in 1937. There is no evidence of this opening ever being used.

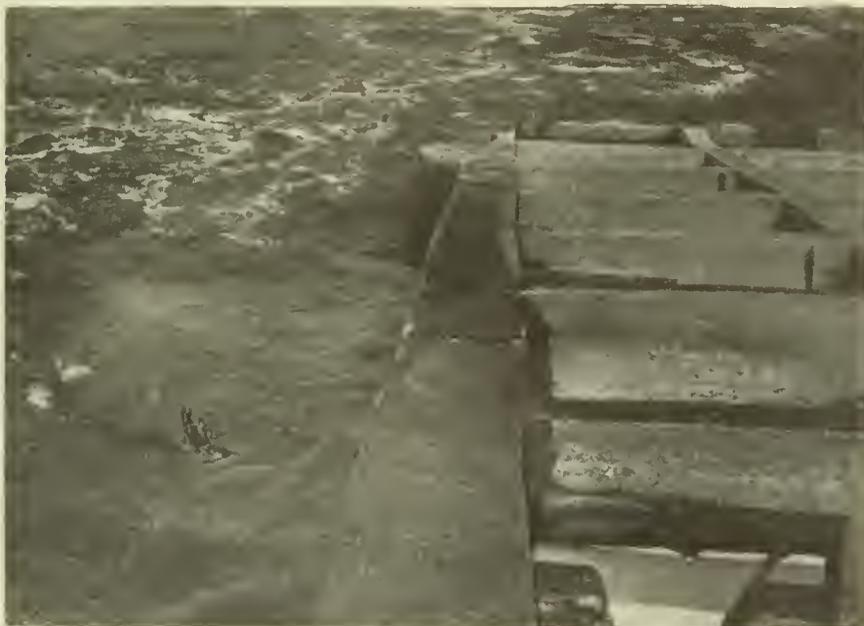
Figure 5.-- Water Conditions at Fishway Entrance

Tailwater Elevation 14.5 ft. (above mean sea level). Note the large rock in the left foreground. The extreme turbulence of the water to the left of this rock can be seen in Figure 4 above.

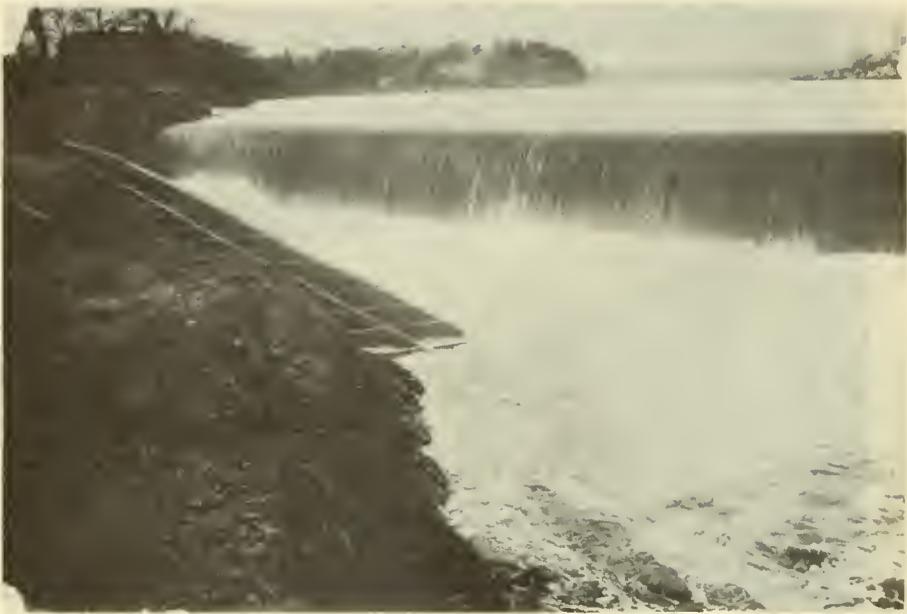
Figure 6.-- General View of Lawrence Fishway
Tailwater Elevation 17 ft. (above mean sea level) Note extreme
turbulence. Shad do not approach the fishway under these water
conditions.

The probable maximum water level at which shad enter is at a tailwater elevation of 14.5 ft. (above mean sea level). At this water level the velocity of the water through the entrance is reduced to about 0.3 ft./sec. and water flows through the opening in the wall of the second pool at about 1 ft./sec. Above this tailwater level the water in the vicinity of the fishway entrance becomes excessively turbulent (Figure 6).

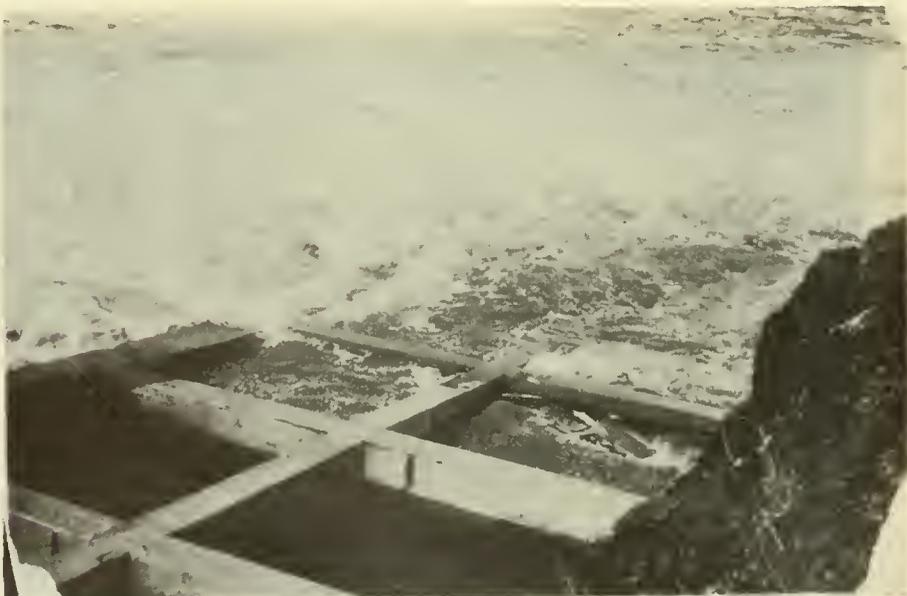
Figure 7.-- Flooded Fishway Entrance
Tailwater Elevation 17 ft. (above mean sea level).

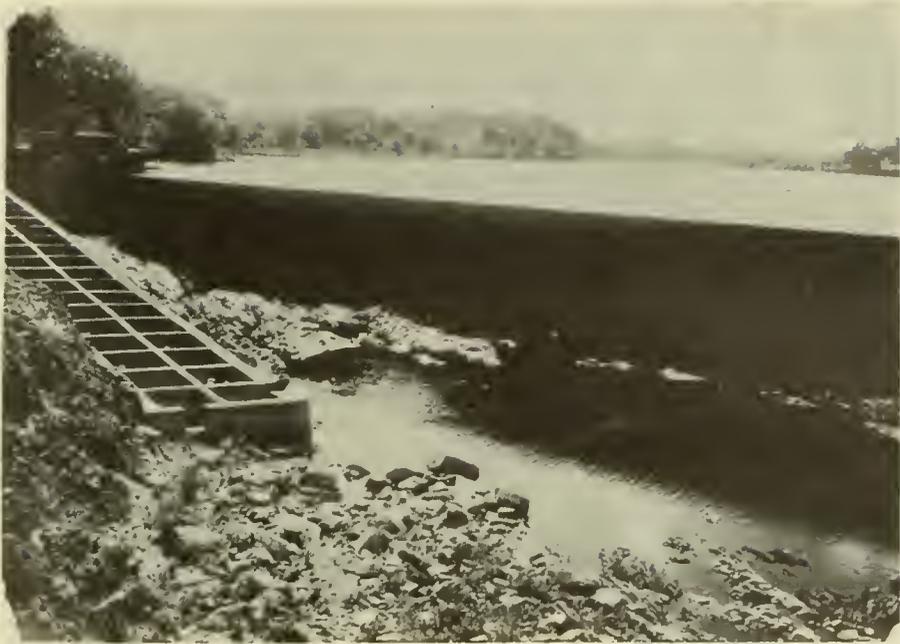
Figure 8.-- General View of Lawrence Fishway
Tailwater Elevation 7 ft. (above mean sea level) No water over spillway. Shad are unable to reach the fishway under these conditions.

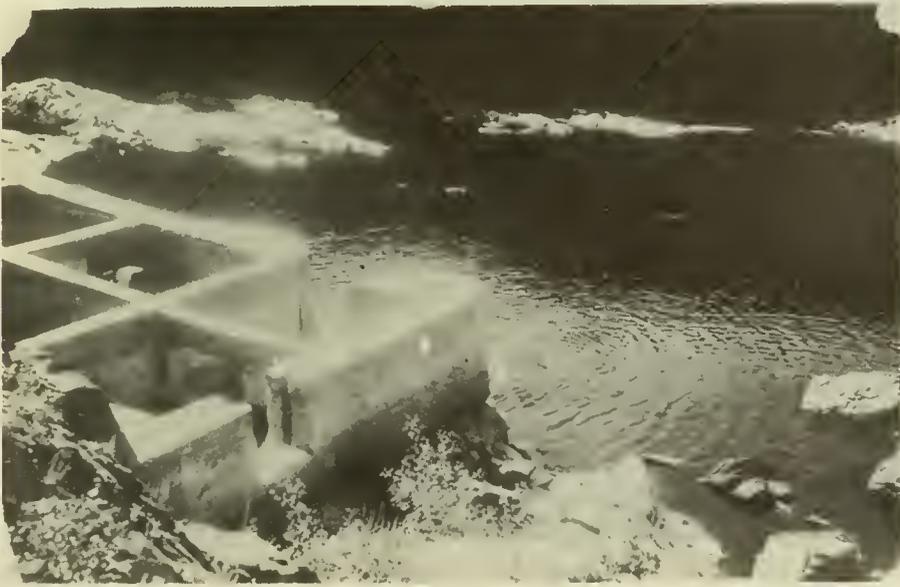
Figure 9.-- Close-up of Fishway Entrance
Tailwater Elevation 7 ft. (above mean sea level)

^{5/} The opening in the side of the second pool (Figure 9) was not made in the model. It is not involved at tailwater elevations of 13 ft. (above mean sea level) or lower and it has very little influence upon the pattern of flow until tailwater elevations exceed 13.5 ft. (above mean sea level). Its main effect is a reduction in the velocity of the flow through the fishway entrance.

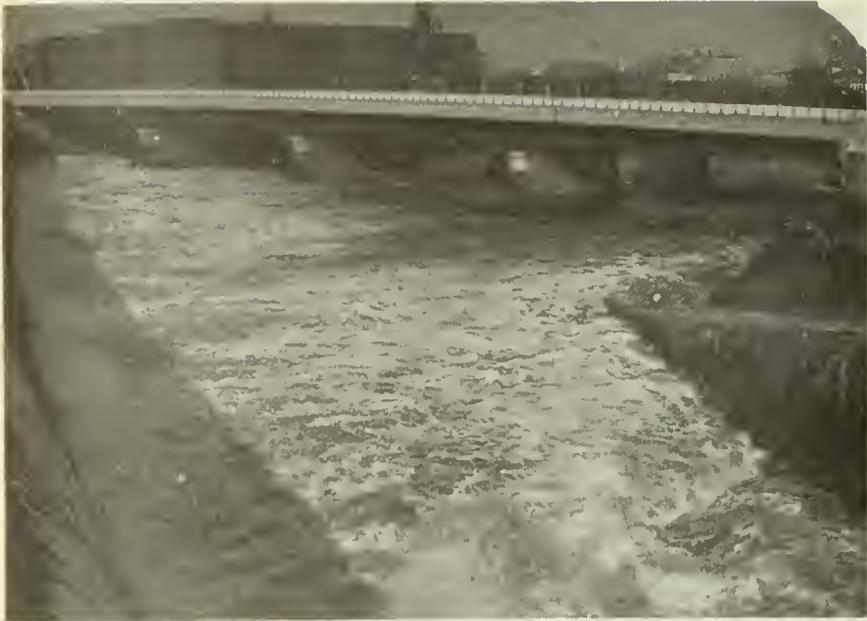
Figure 10. -- View of Lawrence Fishway Facing Downstream
Tailwater Elevation 17 ft. (above mean sea level).

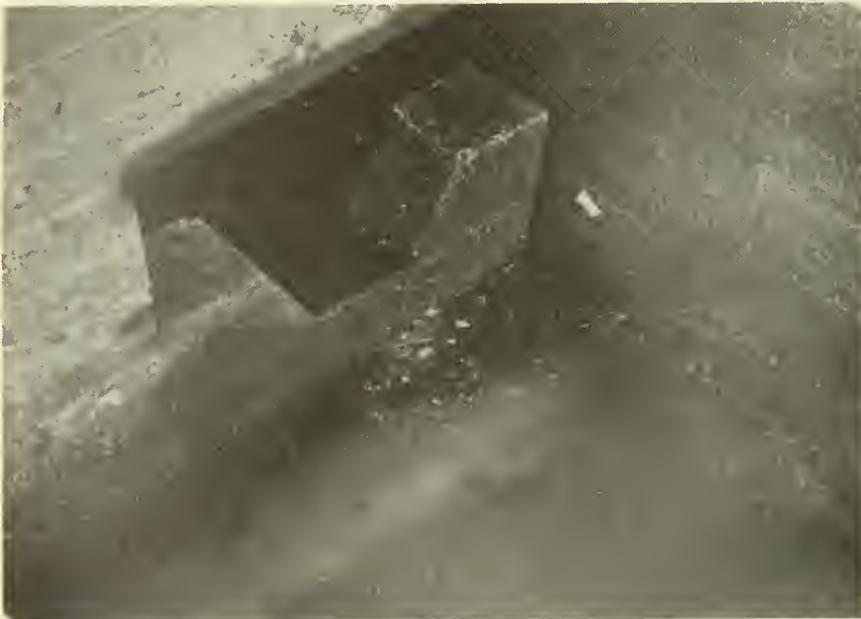
Figure 11. -- Notched Weir.
Note the unusual thickness of the weir and the sloping floor of the notch. The downstream edges of the notch have a 2-inch bevel.

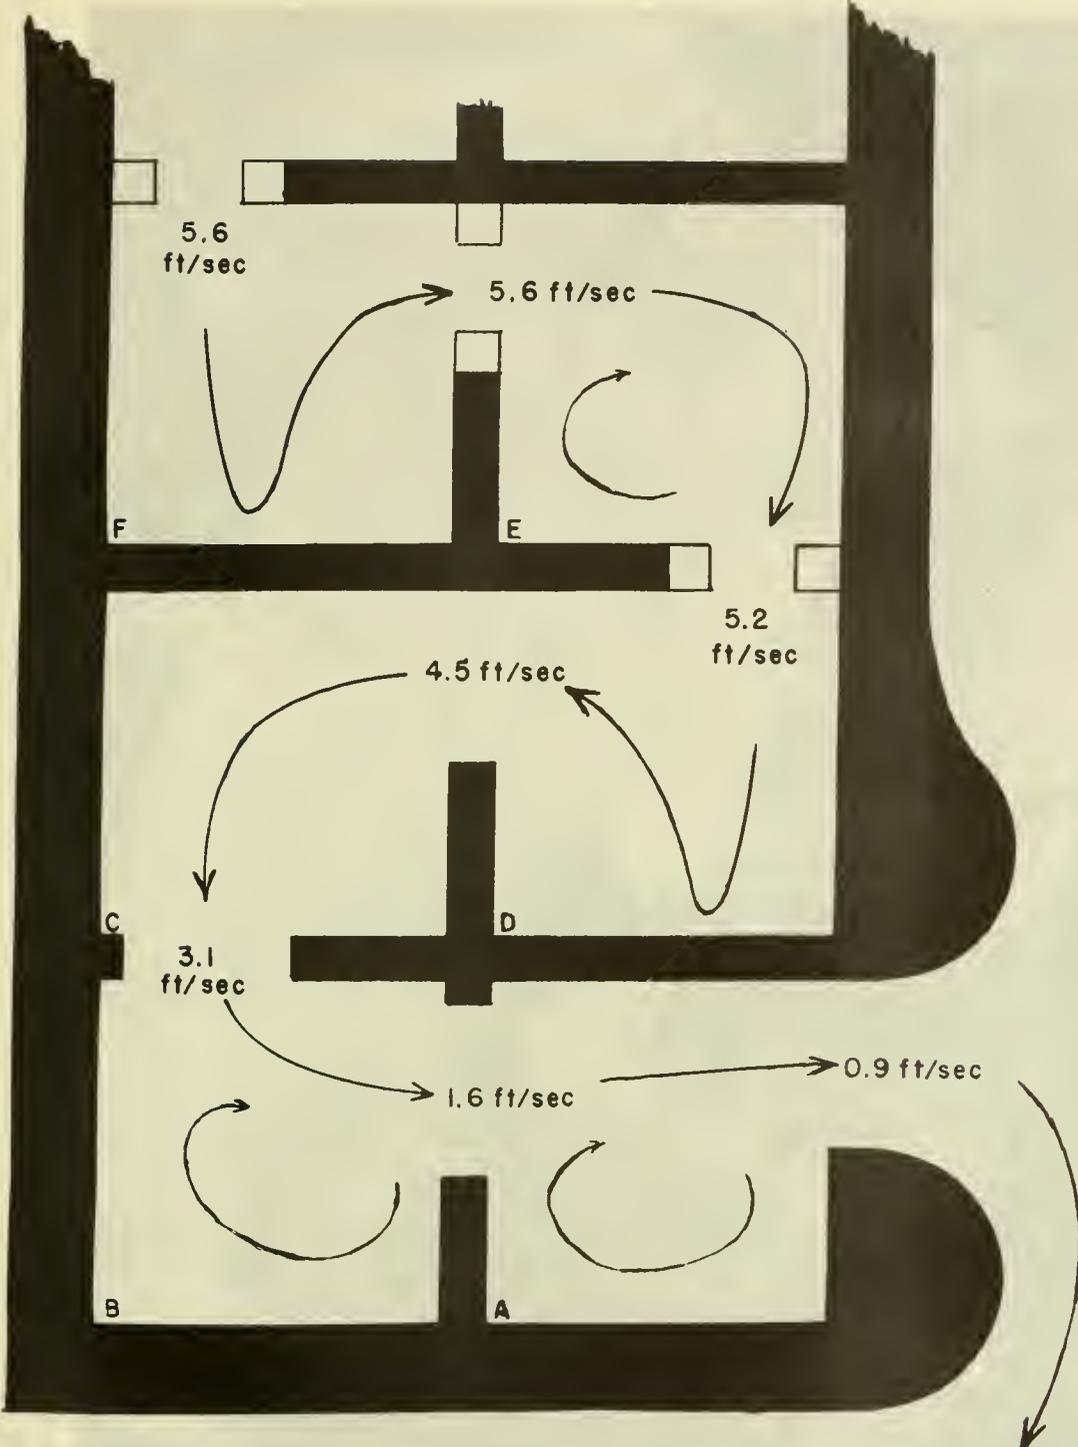
Figure 12.--Diagram of Flow Pattern in Lawrence Fishway
 Tailwater Elevation 13 ft. (above mean sea level). The velocities shown are the maximum velocities in the jet. These velocities exist for only a few inches since the jet dissipates rapidly. In pools E and F all velocities, other than in the jet, were less than 1.5 ft/sec. The arrows diagram the main flow, not surface currents. Note that the first 4 weirs are flooded. The almost 180° change in the direction of flow shown in pools D and F is an undesirable feature. It has been observed that the fish sometimes hit the wall at the turning point. Probably the low water velocities involved keep this from being a serious condition in the Lawrence Fishway.

A comparison was made of the flow patterns in the fishway pools with the two different types of weirs, the original wide weir and the notched weir with its sloping floor. The direction of the main flow (Figure 12) was approximately the same with both types of weirs, although the flow from the notched weir was much more concentrated. The greater depths created by the addition of notched weirs resulted generally in lower velocities and reduced turbulence, particularly in the lower areas of the pools. However, the maximum velocities in the jet produced by the notched weir were about 0.8 ft/sec. higher than the maximum velocities produced by the wide weir. Thus, with the notched weir, there was a much sharper contrast between the velocity of the water in the jet and the velocity of the rest of the water in the pool. With the broad weir and the shallower depth, velocities throughout the pool were more uniform. The condition at the approximately 180° change in the direction of flow in certain pools (Figure 12) is probably accentuated by the concentrated flow from the notched weirs.

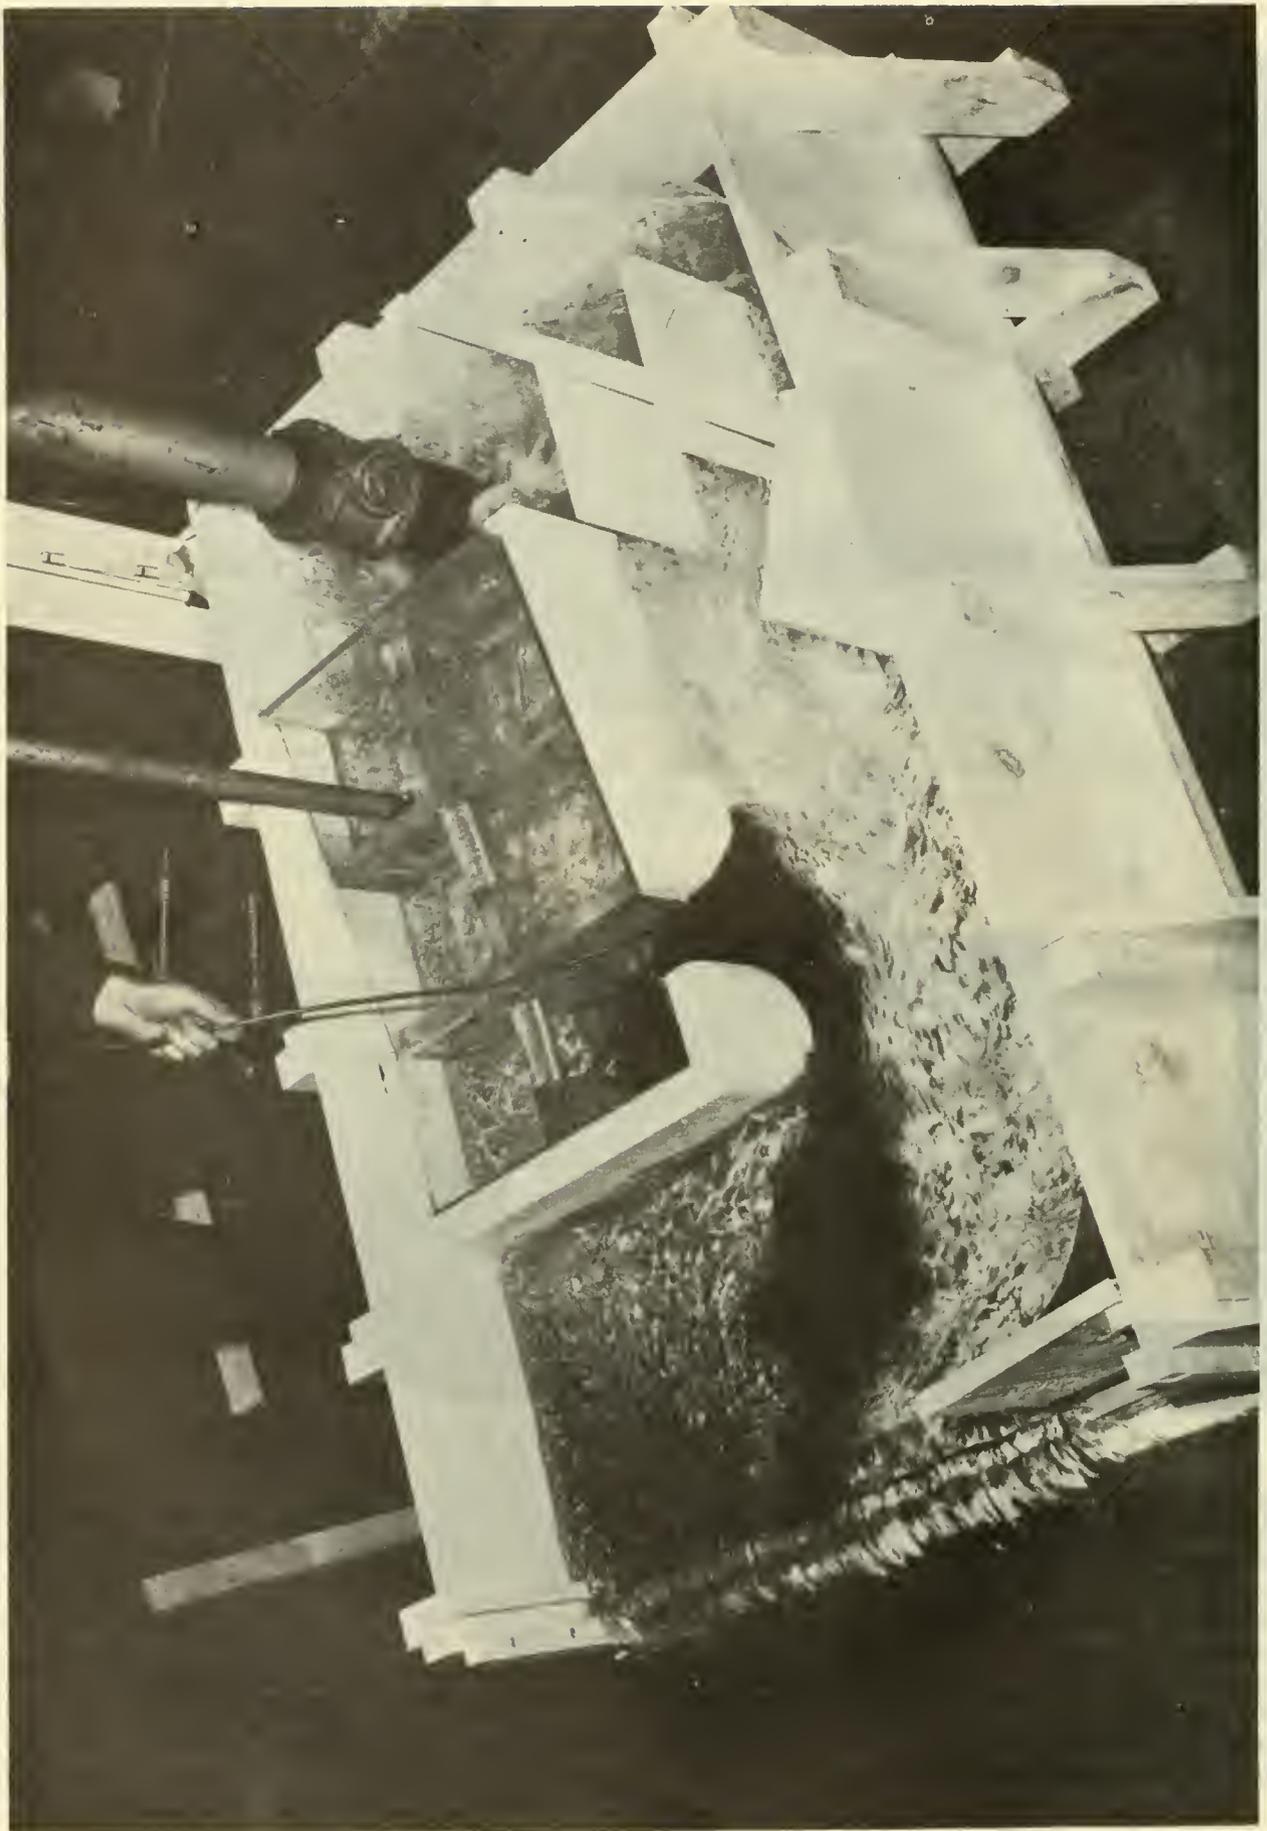
Figure 13. - General View of Fishway Model - (Alden Hydraulic Laboratory)
Tailwater Elevation 13ft. (Above mean sea level) The optimum conditions for entrance of shad into the fishway
are probably at this water level. Note area of reduced velocities at fishway entrance (black dye).

In order to examine in detail the characteristics of flow in the Lawrence fishway under varied water conditions, a plastic model of the lower six pools (Figure 13) was constructed and installed at the Alden Hydraulic Laboratory, Worcester Polytechnic Institute. The model was built according to the original plans (Figures 1 and 2) with removable inserts for the later modifications. Patterns of flow were studied by the addition of dye to the water.

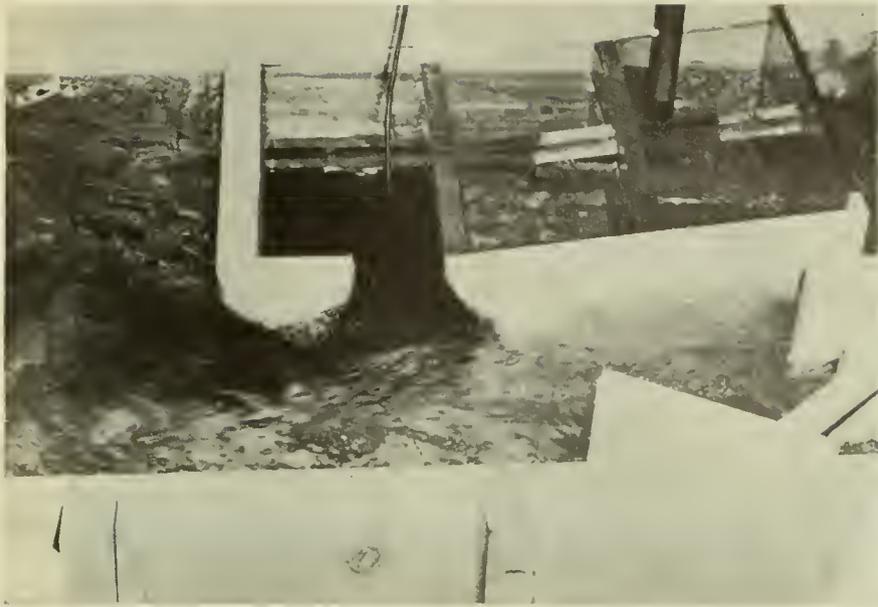
Figure 14.-- Entrance to Fishway (Model)
Tailwater Elevation 15 ft. (above mean sea level) Note flooding
of weirs.

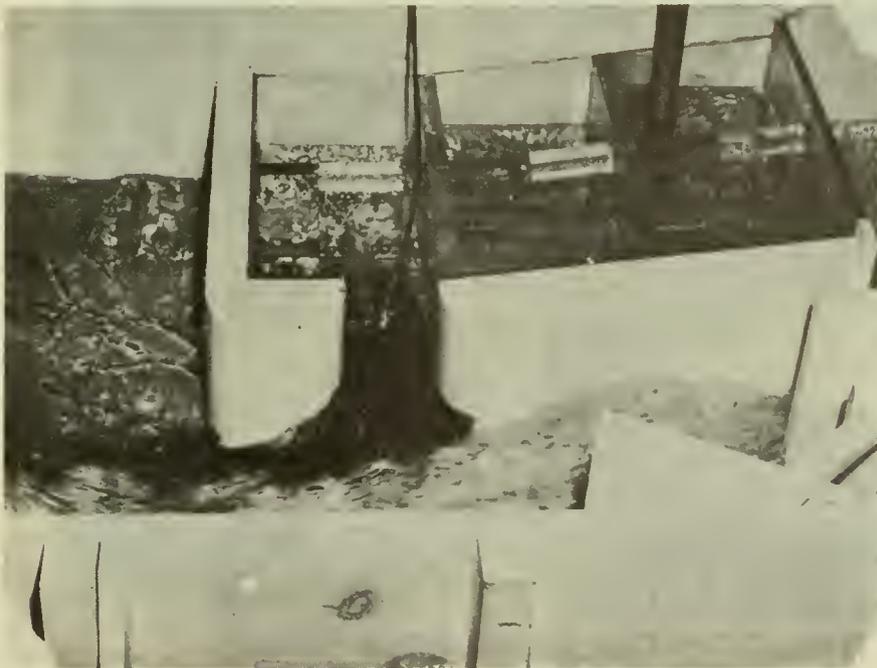
Figure 15.-- Entrance to Fishway (Model)
Tailwater Elevation 11 ft. (above mean sea level) This water level
is probably close to the minimum tailwater level for entrance of shad
into the fishway. Note that the first weir is flooded.
