Barge Transportation of Juvenile Salmonids on the Columbia and Snake Rivers, 1977

ABSTRACT—During the spring of 1977 the National Marine Fisheries Service, in cooperation with the U.S. Army Corps of Engineers, used two cargo tank barges to transport juvenile salmonids down the Snake and Columbia Rivers (through as many as eight dams) to safe release sites in the lower Columbia River. Barge design and performance are described. The transported Pacific salm-

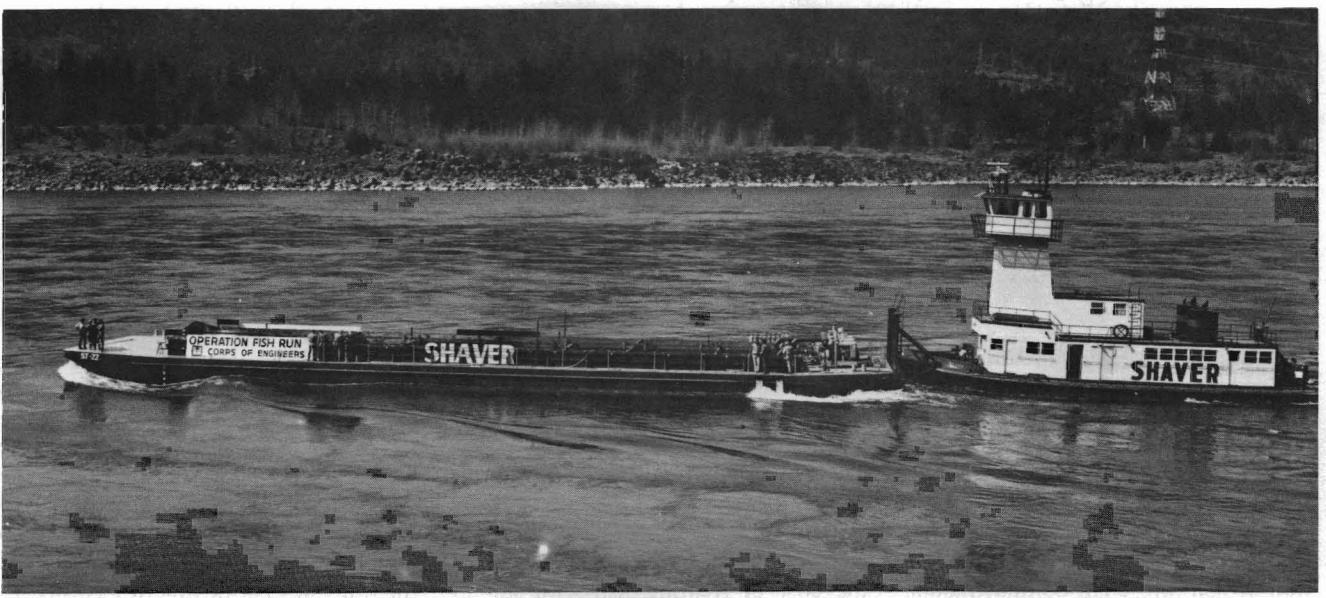
Figure 2.—A fish barge and tugboat on the Columbia River near the release site (photo courtesy of the U.S. Army Corps of Engineers).

Columbia River by the Washington Department of Fisheries in a series of experiments from 1955 to 1958. However, an open type (screened) barge was used (Ellis and Noble, 1960). In our operation, two barges (modified for fish hauling) and a tug boat were employed. Each barge had a steel cargo tank 33.2 m (109 feet) long and 8.5 m (28 feet) wide (Fig. 2, 3). The cargo tank was divided into eight compartments by a longitudinal bulkhead

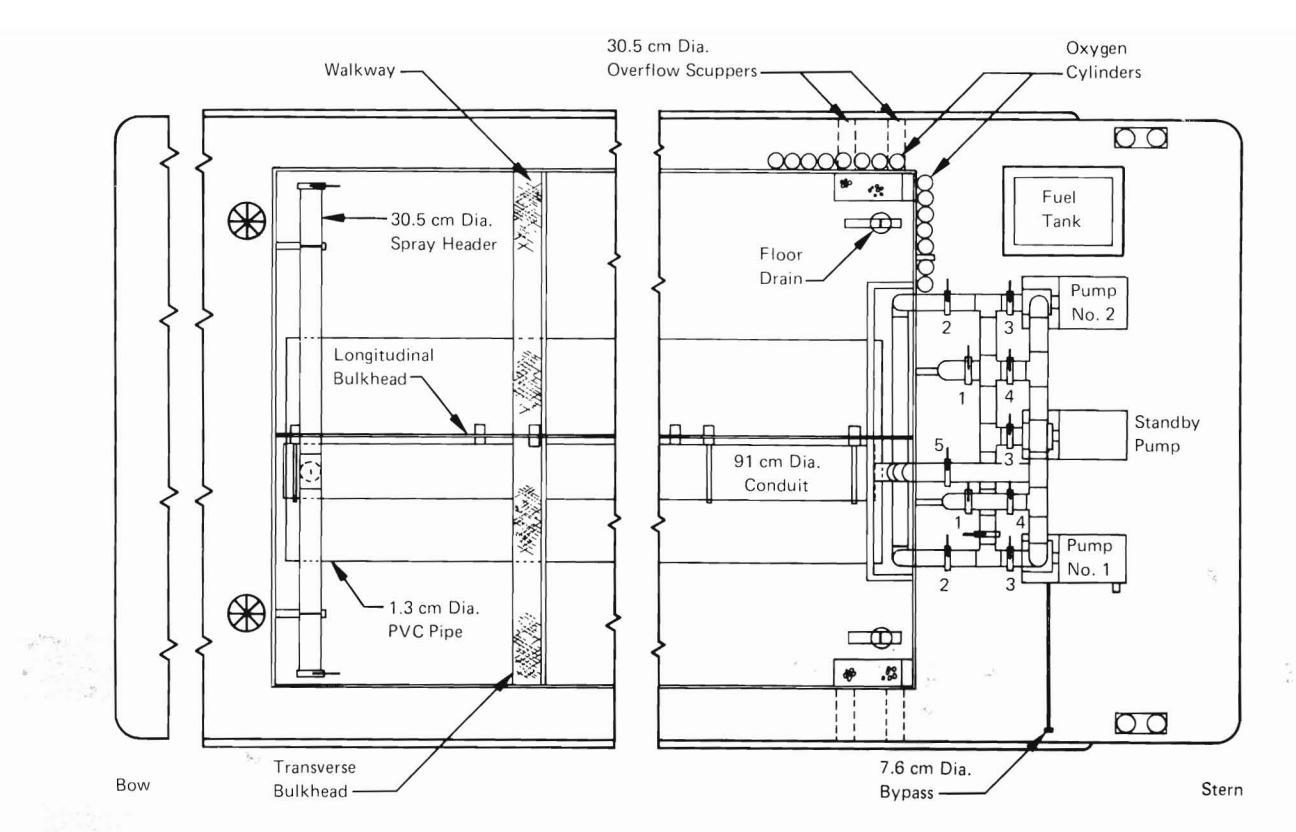
Figure 3.—Overhead view of a fish barge (modified from U.S. Army Corps of Engineers' blueprint). Key to valves: 1) Sea chest, 2) Recirculation, 3) Pump intake, 4) Back flush, and 5) Main discharge.

and three transverse bulkheads. Hinged screens, 2.7 m (9 feet) by 0.9 m (3 feet), were installed in the transverse bulkheads on each side of the longitudinal bulkhead; the six hinged screens, constructed of perforated steel plate (perforations were 4.8 mm or 0.2 inch in diameter), permitted segregation of fish into eight compartments.

The water was pumped through 25.4-cm (10-inch) and 30.5-cm (12-inch) diameter pipes, and subsequently into a 91-cm (36-inch) diameter pipe that extended the length of the cargo space (Fig. 3, 4). Water exiting from the 91-cm (36-inch) diameter pipe flowed into a 30.5-cm (12-inch) diameter perforated pipe which served as a

modified by: 1) Operating either one or two pumps; 2) partially closing the main discharge valve; or 3) opening the 7.6-cm (3-inch) diameter bypass valve (Fig. 3, 4). The average outputs of one and two pumps were 12.9 m³/minute (3,400 gpm) and 20 m³/minute (5,250 gpm), respectively. With two pumps running it took approximately 20 minutes for one complete turnover of water in the barge.

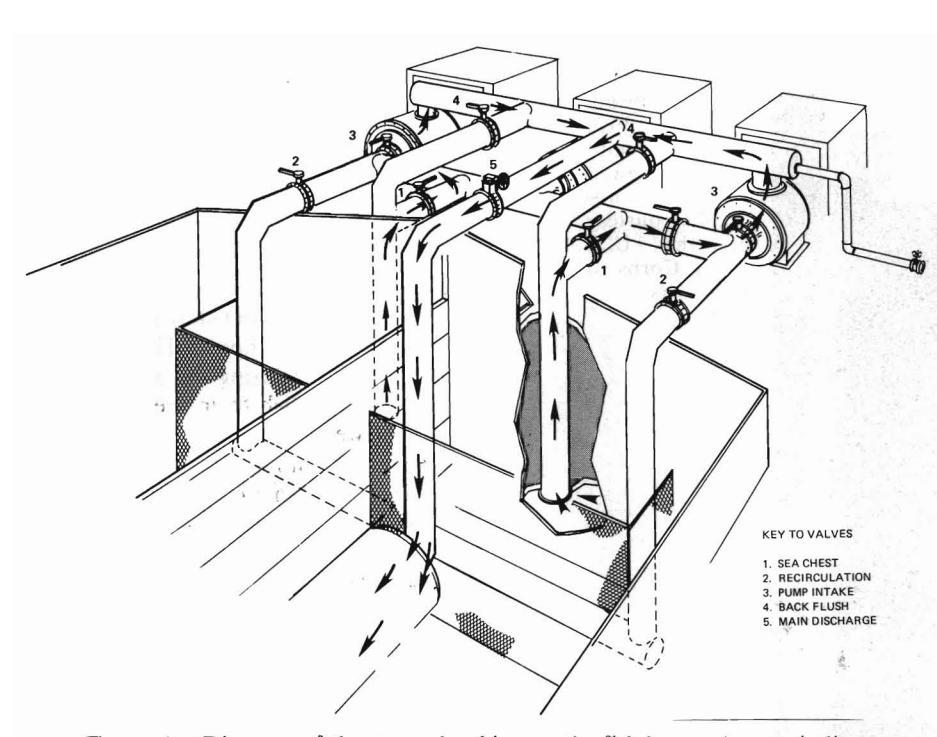
Figure 4.—Diagram of the stern plumbing on the fish barge: Arrows indicate water flow during normal circulation. Valve handles parallel to the flow indicate open valves.

If the intakes of the sea chests became plugged with debris, they could back flushed by opening the back flush and recirculation valves and closing the sea chest valves, thus allowing water in the pipe above the pumps to fall back through the sea chest (Fig. 4). The spray bar could be cleaned of debris by opening butterfly valves on each end.

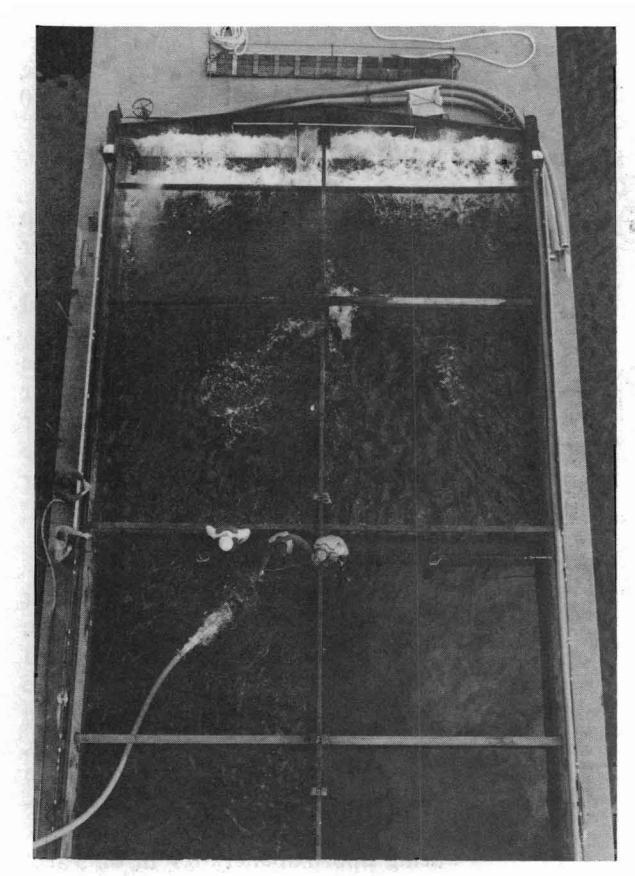
Loading spring chinook salmon from Kooskia National Fish Hatchery into barge at Lewiston, Ida. Photographs courtesy of the U.S. Army Corps of Engineers.

the barge through either 10.2-cm (4inch) or 15.2-cm (6-inch) diameter flexible PVC hoses. All the sharp edges on hose couplings were either chamfered or covered to prevent mechanical injury to fish. When fish were unloaded from tank trucks onto the barge, we used a 3.8-cm (1.5-inch) diameter fire hose connected to the barge's circulation system to flush fish from the truck and the loading hoses. The fire hose was also used during the unloading to flush the last fish from the barge.

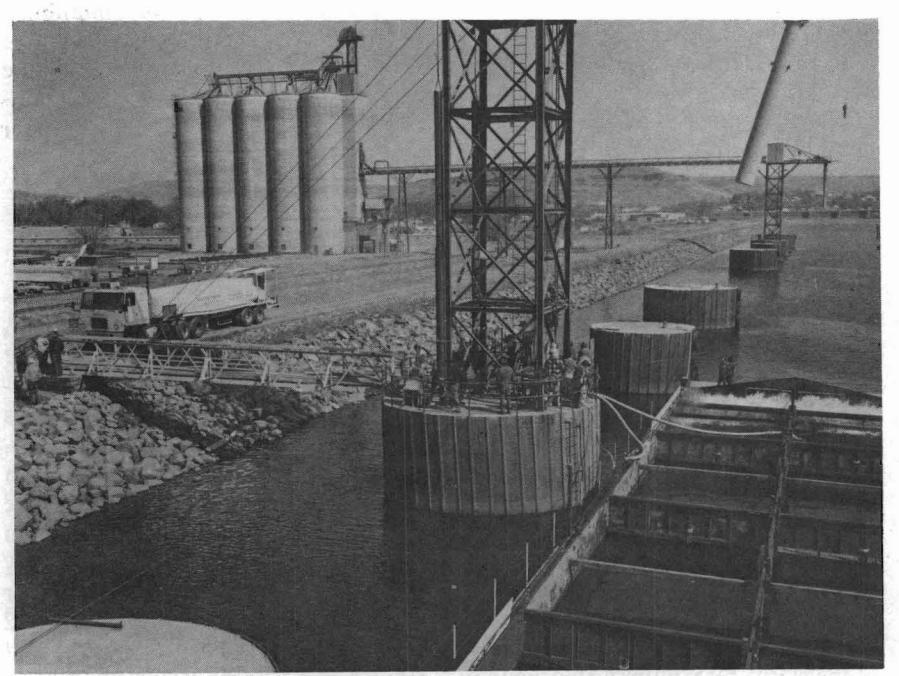
Barge loading site at Lewiston, Idaho. The fish tanker truck is arriving from Kooskia National Fish Hatchery to unload its cargo of spring chinook salmon into the barge. Photograph courtesy of the U.S. Army Corps of Engineers.

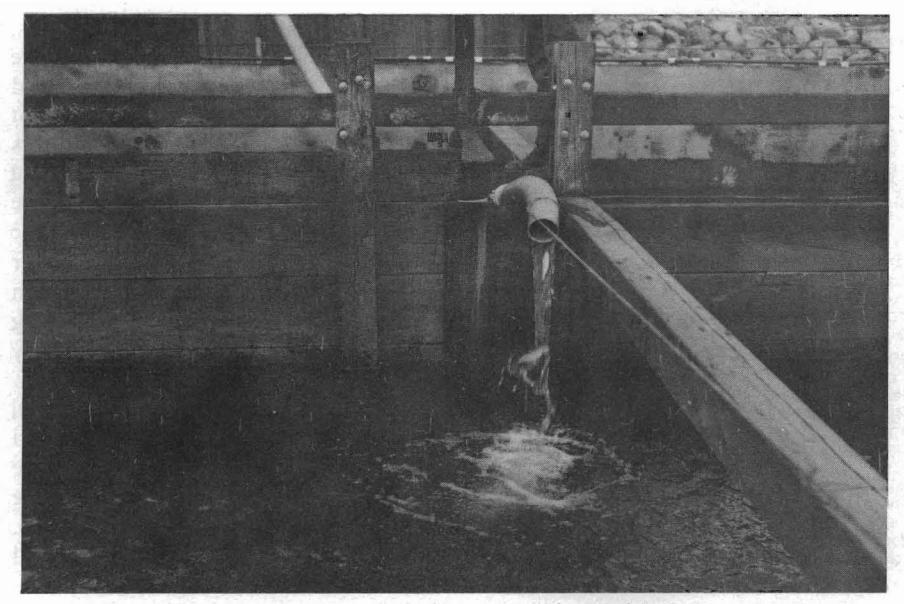
Loading spring chinook salmon from Kooskia National Fish Hatchery into barge at Lewiston, Idaho. Photographs courtesy of the U.S. Army Corps of Engineers.
